**United Nations Disaster Assessment & Coordination (UNDAC)**

**ZANZIBAR POWER CRISIS**

**UNDAC Team  
ENVIRONMENTAL ASSESSMENT  
11<sup>th</sup> – 19<sup>th</sup> June 2008**

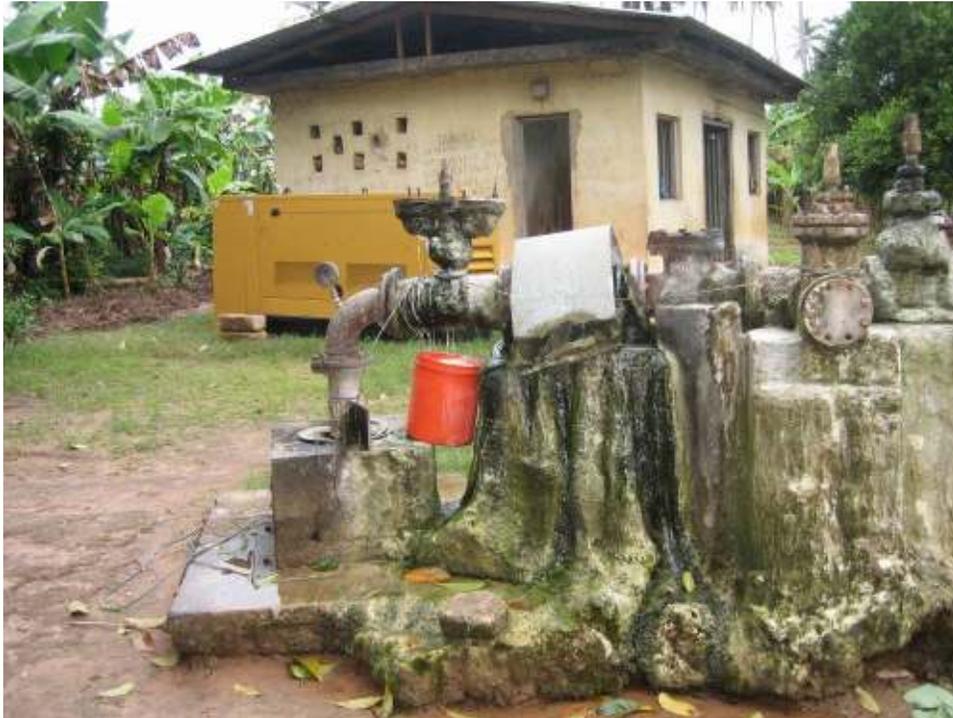
During the assessment several pumping stations were visited. One of these can be seen in the photo below. It was observed that the pump stations were operated at low standards. For example, many of the wells were not fenced, and some well-heads were not closed, meaning that contaminants can enter the aquifer and the supply system.

**A pump station operating on a generator provided by UNICEF/Danida**

- To provide clean and safe water, pumping stations should meet operational standards to be developed and provided by ZAWA. The UNDAC team environmental expert proposed elements of such standards to ZAWA, using World Bank guidance as a basis.

- Generators at pump stations should be installed according to "Environmental guidelines for installation of temporary generators," being prepared by the Zanzibar Environmental Department.

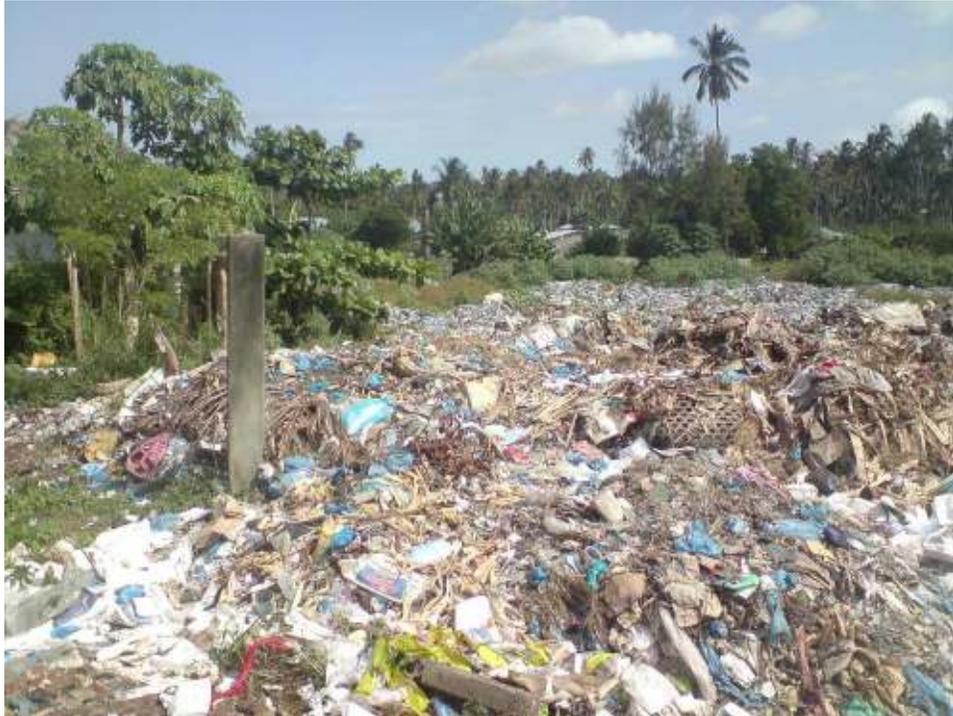
The municipal landfill in Jumbi, about 12 km east of the Zanzibar Town, was visited during the Mission. The landfill includes an area of about 20,000 m<sup>2</sup> (~170 m \* 150 m) in an old stone quarry. It is operated as an open waste dump centre inside the residential area of Jumbi village. The dumpsite is clearly poorly managed, without, for example, bottom-linings and top cover. The dumpsite is not fenced and the public (including children) have free access.

The Municipal landfill in Jumbi located about 12 km east of the Zanzibar Town

The absence of a bottom-lining and top cover at the waste dump site increases the risk of water-borne disease due to washing out of contaminants to the groundwater and wells now being used by residents as a result of the power outage. The fact that the dumpsite is situated in an old quarry means leakage water is close to the groundwater table. It should also be noted that the lack of top cover contributes to bad odour and increases the risk of spreading of air borne diseases to the neighbouring communities. The air borne contaminants could further contribute to respiratory diseases, with children at particular risk.

- A management plan for the Jumbi landfill must be put in place, using as a starting point the recommendations made in 2005.
- The landfill should be fenced to prevent public access to the site.

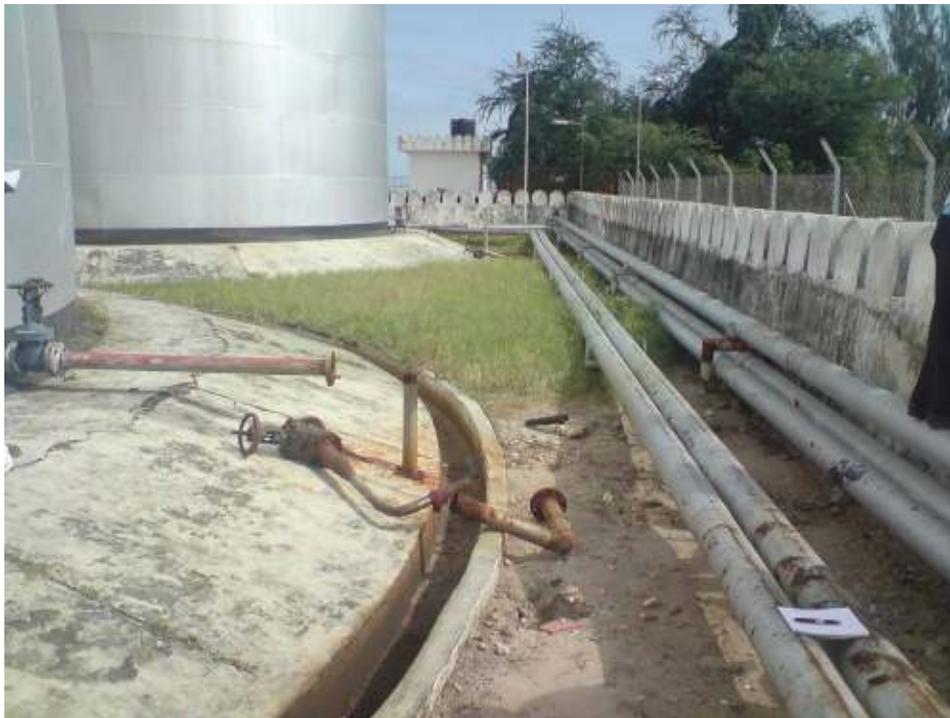
The tanks are placed on a concrete foundation directly on the ground (see photo below). The four tanks are placed inside a concrete wall (bunding). The (functioning) pump station is placed on a concrete plate with bunding. The filling station is placed on a concrete plate surrounded by a drainage system.

Delivery of fuel is by ship. Once the ship has anchored up in the bay the oil is pumped from the ship to the tanks by a flexible delivery hose. No oil-pier exists and the oil-hose is submerged on top of the seabed. After delivery, the oil storage tank is drained manually by opening the valve in the bottom of the tank (see photo below). Drainage water for the tanks is drained directly into the ground and/or via an open drainage system into the bay without treatment.

Tank farm at GAPCO Oil Company. The valve and pip on the left is used to drain seawater from the tank.

During the site, visit oily water from the facilities was observed draining into the bay.

The installations were observed to be of very low environmental standard. The present delivery process of oil poses a risk of ongoing release of free oil directly into the bay, with a negative effect on the marine environment. This, in turn, could likely affect the food chain and ultimately human health, over the longer-term. The wall surrounding the tanks will only give limited protection with respect to spreading of oil in case of a major leak from one or several tanks mainly due to the open drainage system around each tank draining directly into the bay and secondly due to no bottom lining in the tank farm to prevent oil to enter into the ground and eventually into the bay via the groundwater having the same negative effect to the environment as above.

- **A thorough environmental audit of the facility should be preformed by the Zanzibar Environmental Department.**
- **To prevent a major oil spill entering into the ground and the bay, all tank farms should be bunded. Bunding should be to 120% of the capacity of the tanks.**
- **All drainage systems should be connected to oil separators and a proper waste water treatment plant to facilitate the whole oil storage facility should be implemented.**
