Environmental Expert Support Mission
United Nations Disaster Assessment and Coordination
Water contamination

Technical Report
Hurricane Matthew, Haiti – October 2016

Joint UNEP/OCHA Environment Unit
Prepare. Respond. Protect.

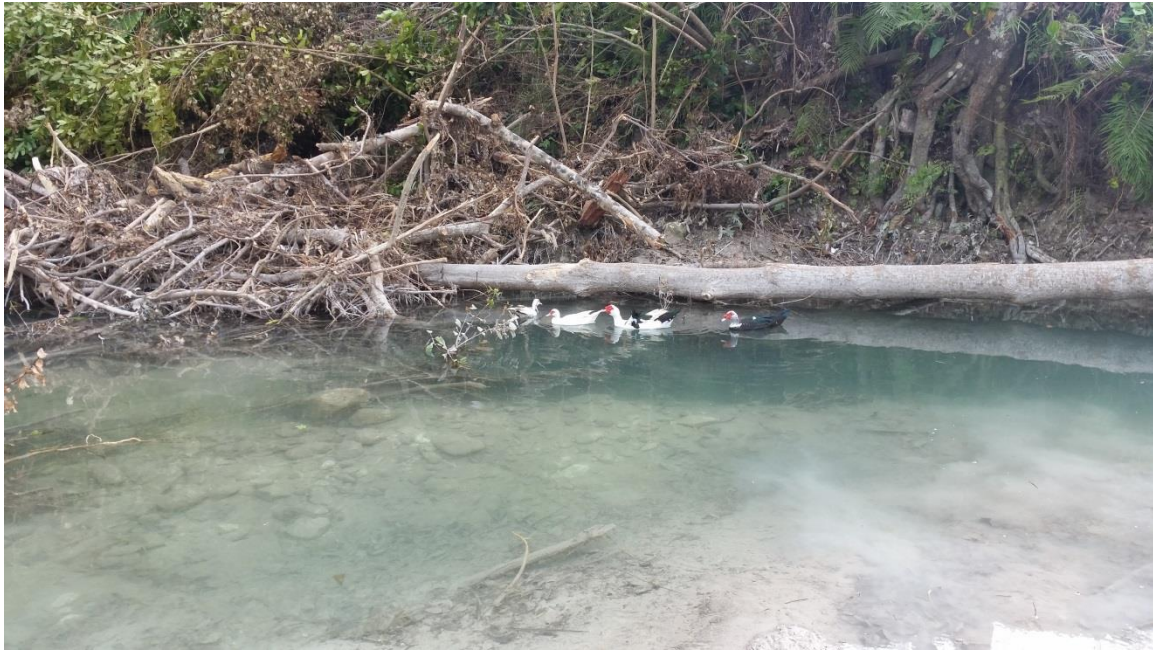
As part of their assessments the experts visited several water catchments and water systems, as shown in Picture 1, in order to understand and verify the damages. Subsequently, they sampled water in almost all of the visited localities to find out if there was water contamination, which would impact people's health.

Picture 1. Water catchment area, Port-Salut, Haiti @Eva Andersson

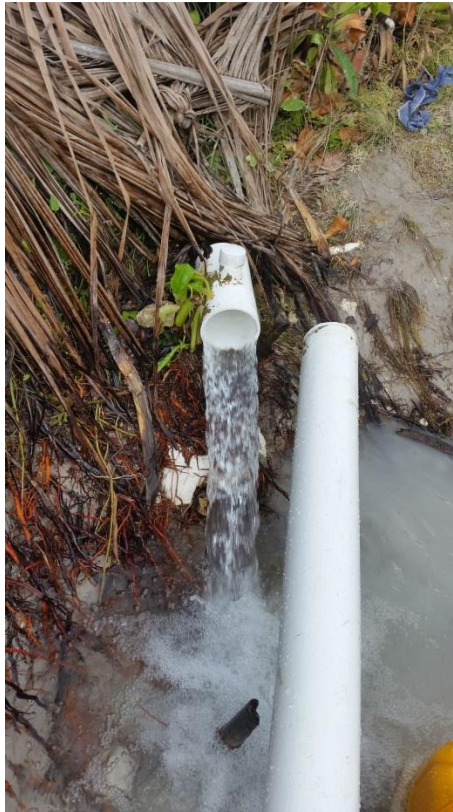
The findings regarding the first water system exposed that, despite the hurricane passage, the structure was still intact. However, Picture 2 shows that the pipes linked to the water system were buried under the vegetation that dropped and accumulated during the storm. Because of this, it was difficult to assess if the water was coming from under the debris. Moreover, as the exposed pipes were in risk of degradation the water, leaking from the damaged pipes, could easily be contaminated.

Picture 2. Broken pipes after Hurricane Matthew, Cascade, Port-Salut, Haiti @Eva Andersson

Based on the site visits and analysis, the experts developed recommendations which are similar for each of the visited sites. The mission concludes that water must be boiled and chlorinated before being consumed. The population must be informed on the risk of contaminated water in the catchments. Moreover, debris around the catchments should be immediately removed. The damaged pipes can then be repaired, limiting the risk of contaminated water to the population.

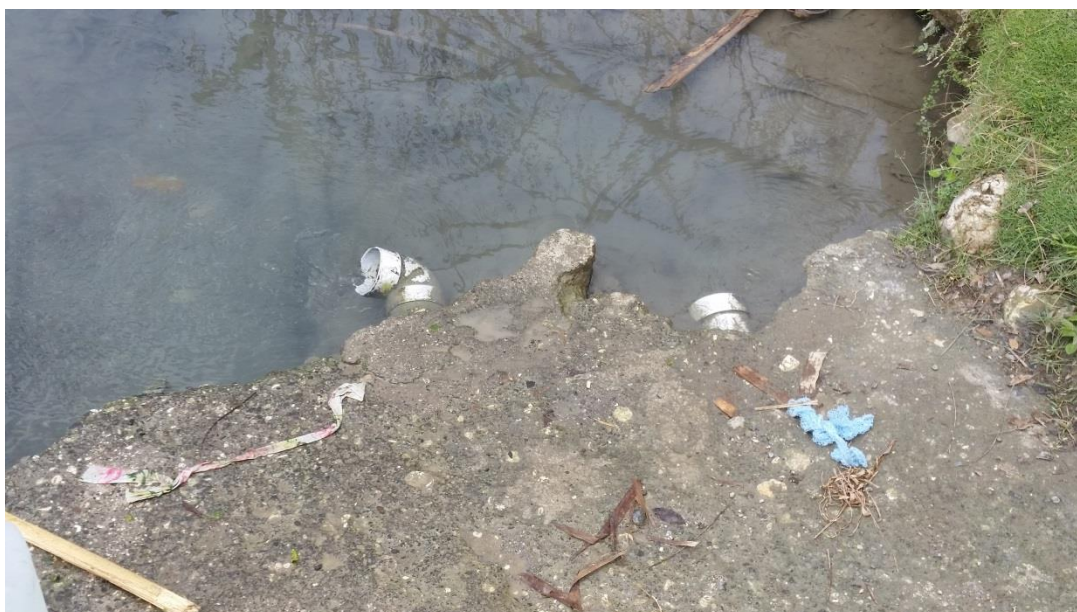
The second basin analysis showed that the flow of water was interrupted in six out of eight water fountains linked to the catchment, while the water flow had decreased in two fountains near the catchment. Conducted examinations showed that the catchment was filled up with silt and supposedly the conveyance pipe was obstructed (Picture 3), limiting the flow and the pressure of the water. However, the catchment was in good condition as the three access hatches were locked. Interviews with local representatives revealed that the community wants to develop a project to rearrange a reservoir and increase the pressure and the redistribution of water.

Picture 3. Broken and obstructed pipes at the Rosier water catchment, Roche-a-Bateau, Haiti @Eva Andersson

In the silt filled catchment in Rosier, it is recommended to remove silt from the inside of the basin and the pipes as soon as possible.

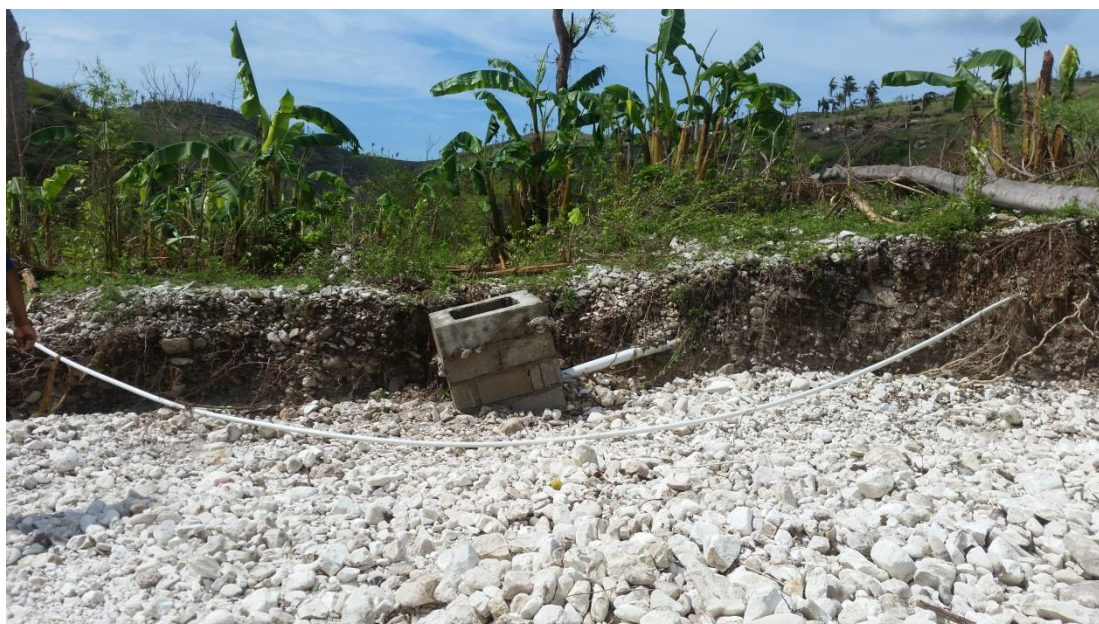
The most concerning results were found in the area of Nathan, Roche-a-Bateau, where the water system was completely broken because of Hurricane Matthew, as shown in Picture 4. Water sampling in this area showed the level of e-coli being superior to 100 as well as the level of coliforms. Similar levels were registered in Port-a-Piment, where only two out of six pumps were working. In Saint Jean du Syd, the water system was not working at all due to fallen trees blocking the source. For this reason, the experts were unable to sample water in that area.

Picture 4. Broken water system following Hurricane Matthew, Nathan, Haiti @Eva Andersson
