Rapid assessment of acute environmental risks after Hurricane Dorian

The Bahamas
September 2019

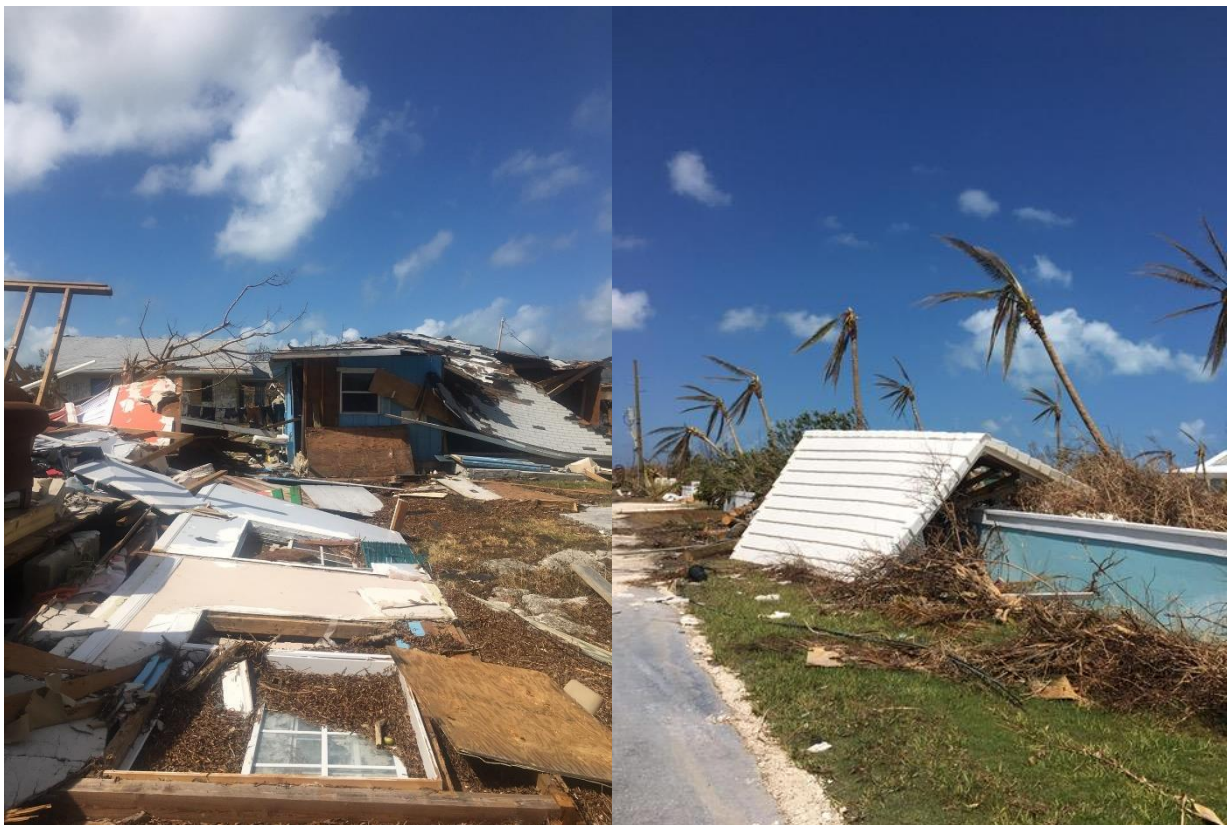
Figures 1 (left) and 2 (right): disaster waste generated by Hurricane Dorian on Abaco Islands

In particular, the hurricane generated large quantities of disaster waste. Aerial footage of the affected areas as well as site surveys show widespread disaster waste (Figures 1 and 2), including hazardous waste that requires adequate disposal. Disaster waste threatens human health, hinders recovery and reconstruction efforts and can significantly impact the environment.

Disaster waste hampered access to key humanitarian routes after the hurricane. While debris clearance was initiated in the immediate response phase to restore access, no considerations on waste segregation and handling hazardous materials were applied in practice, posing challenges for post-disaster management. Landfill capacities on both islands are limited compared to the amount of waste produced, requiring the identification of temporary disposal sites.

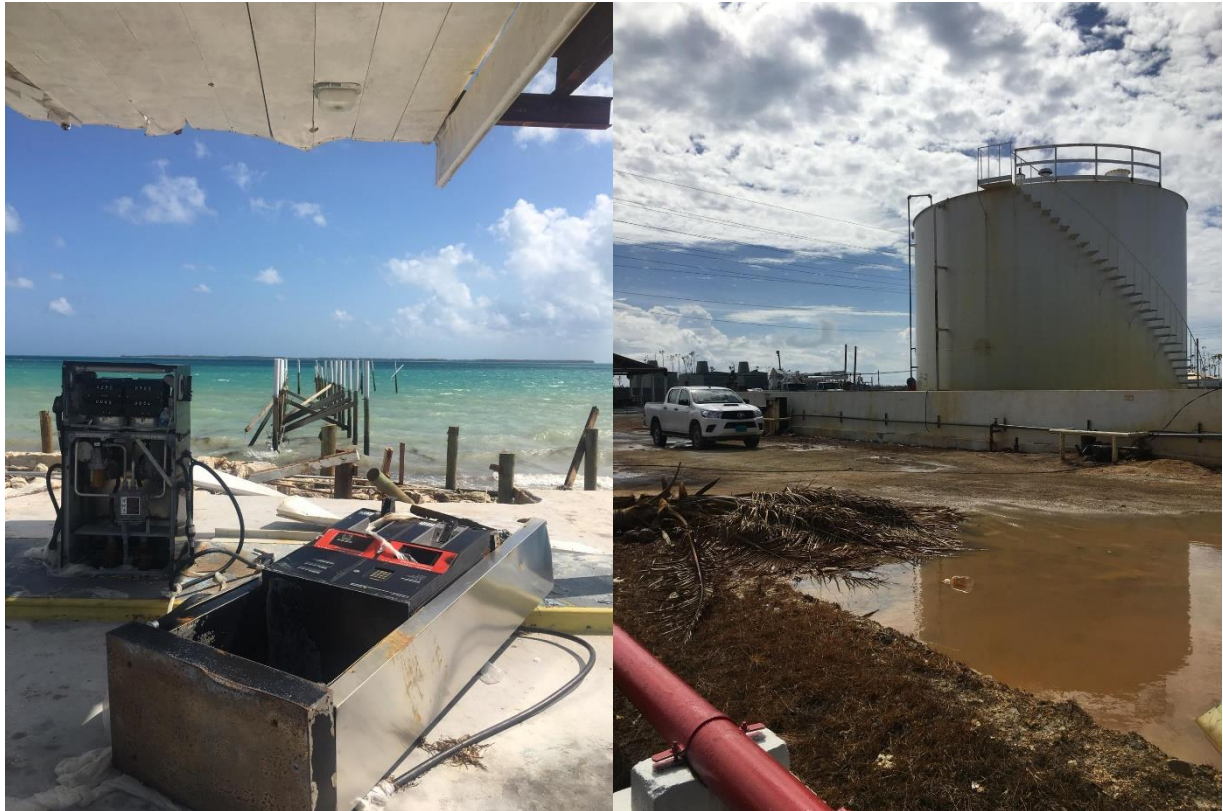
Figures 3 (left) and 4 (right): damaged gas station in Cooper's Town, Abaco Islands (left); diesel fuel leak at Marsh Harbour power sub-station (right)

Several hazardous operation facilities are located on Abaco and Grand Bahama Islands, many of which were severely impacted by Dorian (Figures 3 and 4), leading to the generation of hazardous waste and with potential for additional negative impacts to human health, livelihoods and the environment.

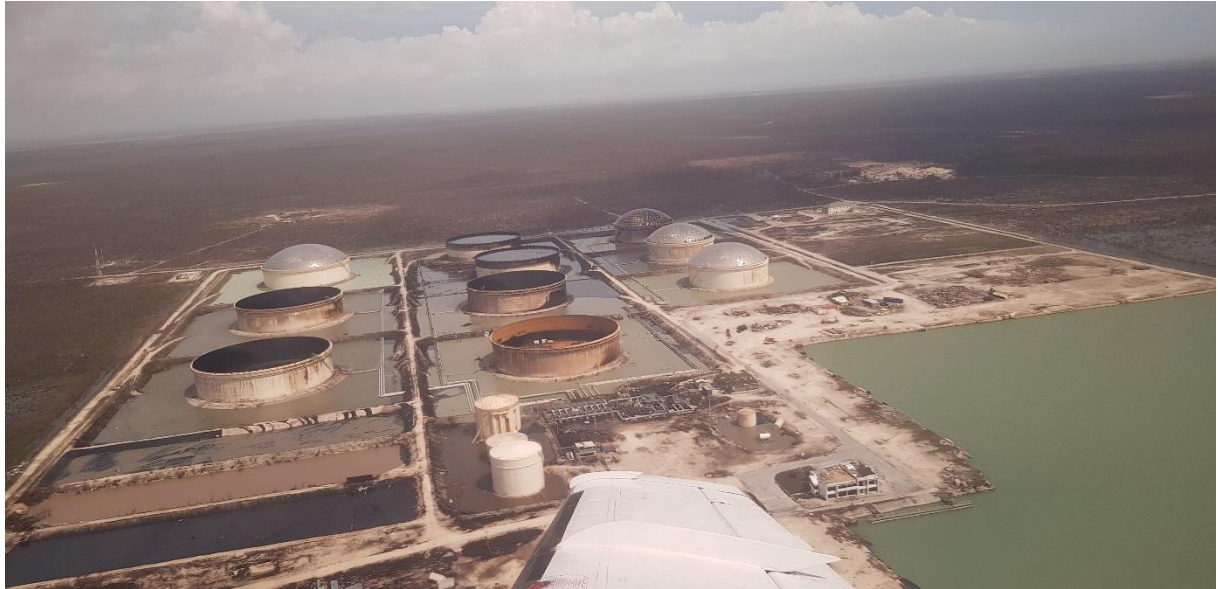
Figure 5: Inland spill of crude oil from Equinor oil storage facility as of 4 September 2019 (© PAHO)

Dorian significantly impacted one of two oil storage facilities located on Grand Bahama Island, with a confirmed inland spill of crude oil from Equinor's South Riding Point terminal. Operations at the terminal were shut down on 31 August as a precautionary measure in view of the hurricane warning. On 5 September, Equinor reported² that the facility had sustained damage based on findings from preliminary aerial assessment. An inland spill of crude oil towards the northeast was confirmed and noticeable from photo evidence made available by PAHO after an aerial assessment conducted on 4 September, further to the all-clear (see Figure 5 below). The operator subsequently engaged oil spill response resources to respond to the event and initiate the clean-up.
