# Rapid assessment of acute environmental risks after Hurricane Dorian

**The Bahamas**  
**September 2019**

Rapid assessment of acute  
environmental risks after Hurricane  
Dorian on Abaco Islands

# Hurricane Dorian's impact on oil storage facilities

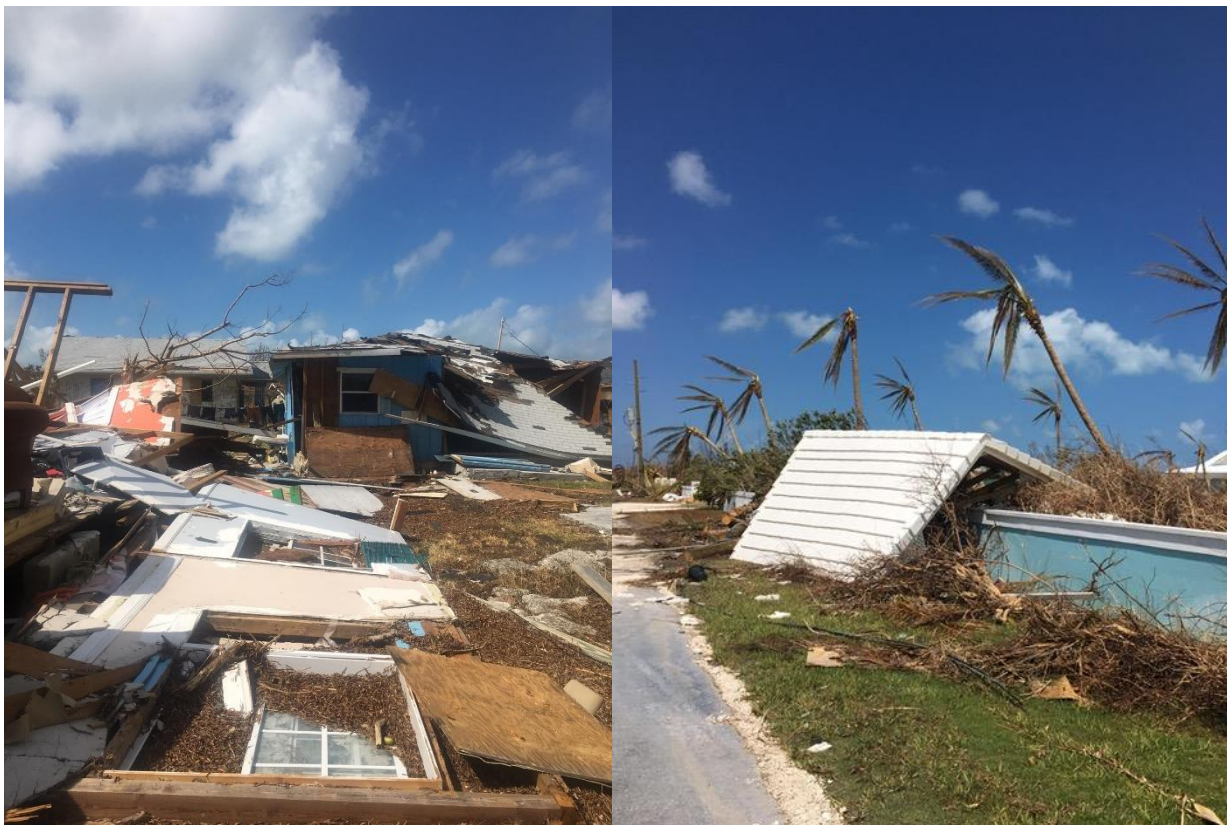
In particular, the hurricane generated large quantities of disaster waste. Aerial footage of the affected areas as well as site surveys show widespread disaster waste (Figures 1 and 2), including hazardous waste that requires adequate disposal. Disaster waste threatens human health, hinders recovery and reconstruction efforts and can significantly impact the environment.

*Figures 1 (left) and 2 (right): disaster waste generated by Hurricane Dorian on Abaco Islands*

Disaster waste hampered access to key humanitarian routes after the hurricane. While debris clearance was initiated in the immediate response phase to restore access, no considerations on waste segregation and handling hazardous materials were applied in practice, posing challenges for post-disaster management. Landfill capacities on both islands are limited compared to the amount of waste produced, requiring the identification of temporary disposal sites.

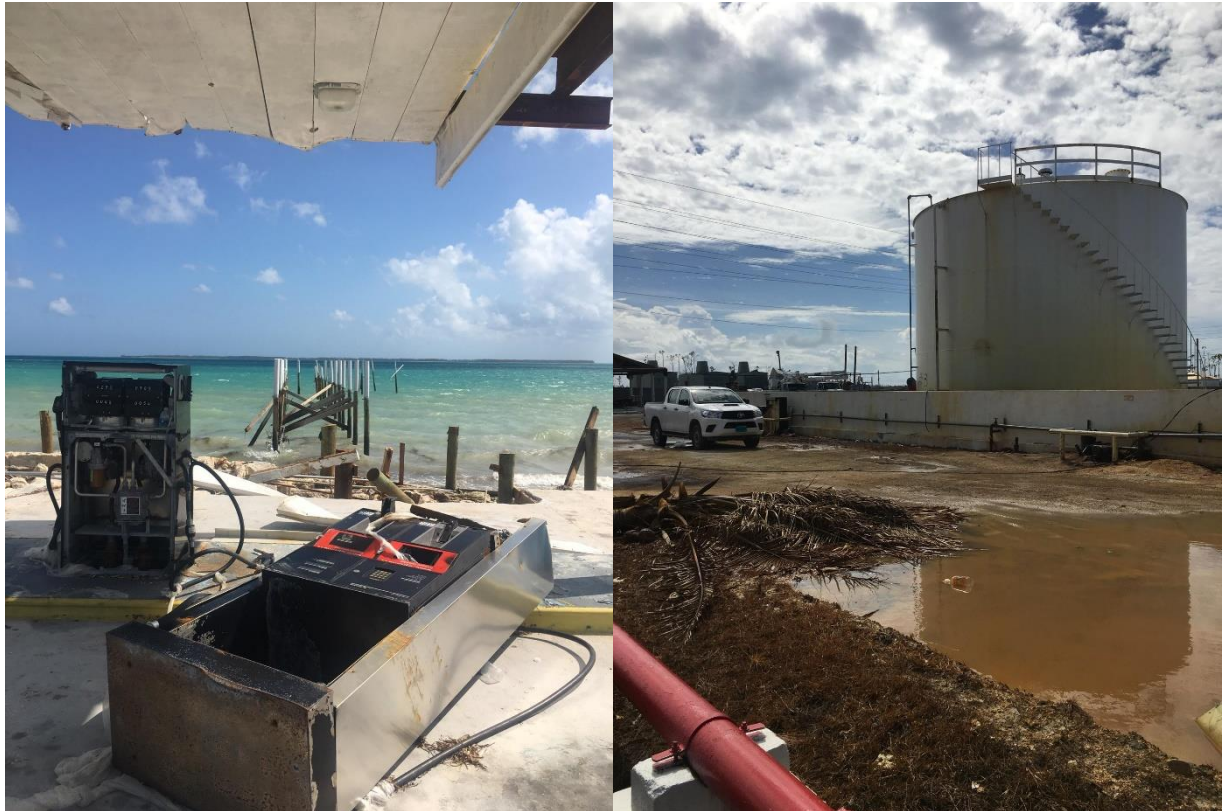
Several hazardous operation facilities are located on Abaco and Grand Bahama Islands, many of which were severely impacted by Dorian (Figures 3 and 4), leading to the generation of hazardous waste and with potential for additional negative impacts to human health, livelihoods and the environment.

*Figures 3 (left) and 4 (right): damaged gas station in Cooper's Town, Abaco Islands (left); diesel fuel leak at Marsh Harbour power sub-station (right)*

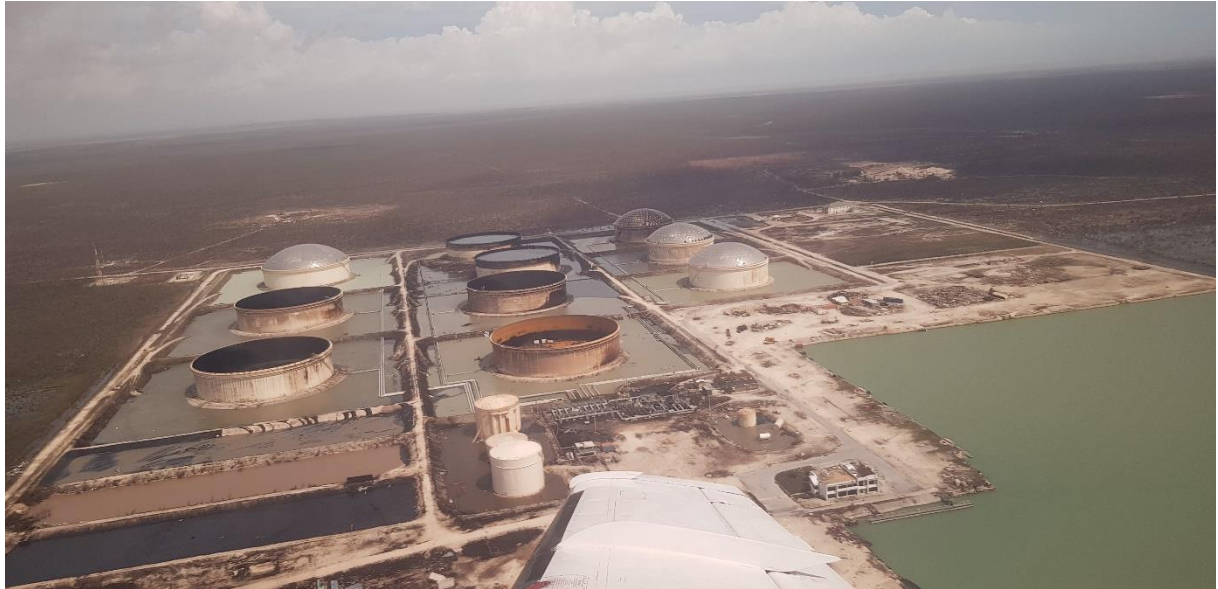
Dorian significantly impacted one of two oil storage facilities located on Grand Bahama Island, with a confirmed inland spill of crude oil from Equinor's South Riding Point terminal. Operations at the terminal were shut down on 31 August as a precautionary measure in view of the hurricane warning. On 5 September, Equinor reported<sup>2</sup> that the facility had sustained damage based on findings from preliminary aerial assessment. An inland spill of crude oil towards the northeast was confirmed and noticeable from photo evidence made available by PAHO after an aerial assessment conducted on 4 September, further to the all-clear (see Figure 5 below). The operator subsequently engaged oil spill response resources to respond to the event and initiate the clean-up.

*Figure 5: Inland spill of crude oil from Equinor oil storage facility as of 4 September 2019 (© PAHO)*

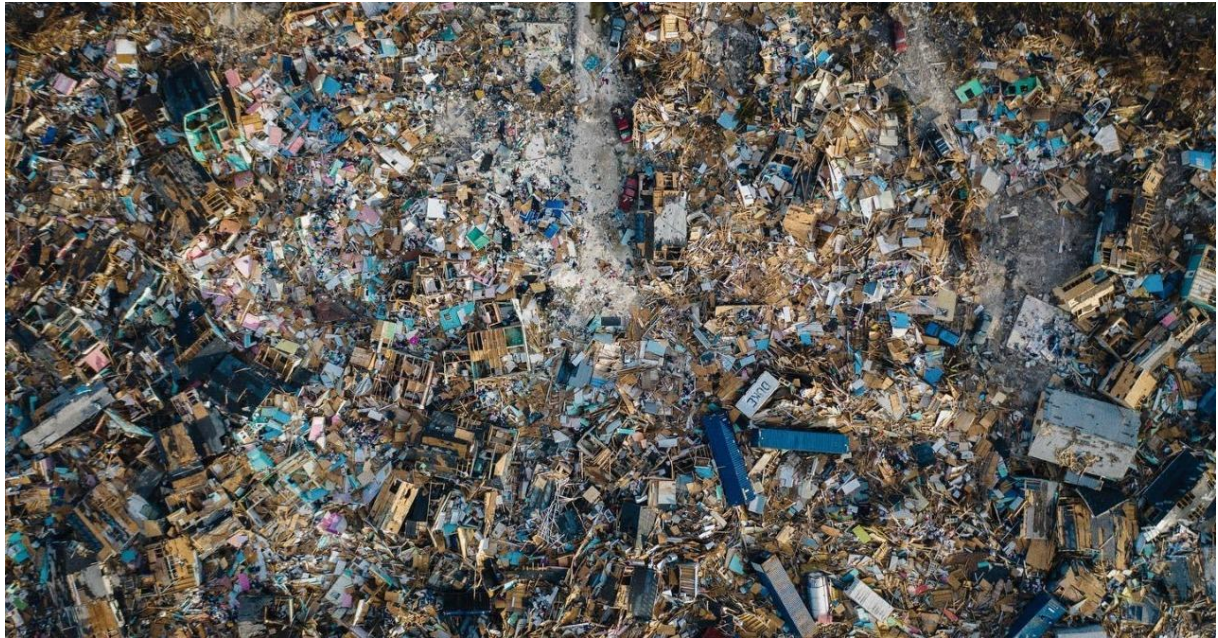
The hurricane generated massive quantities of debris and rubble (Figure 2). Preliminary estimates from the United Nations Development Programme (UNDP) quantified a total of two million m<sup>3</sup> of waste produced by the hurricane in Abaco alone.

*Figure 2: drone view over some of the most affected areas in Marsh Harbour, showing the extent of devastation and accumulation of disaster waste (© Samaritan's Purse)*

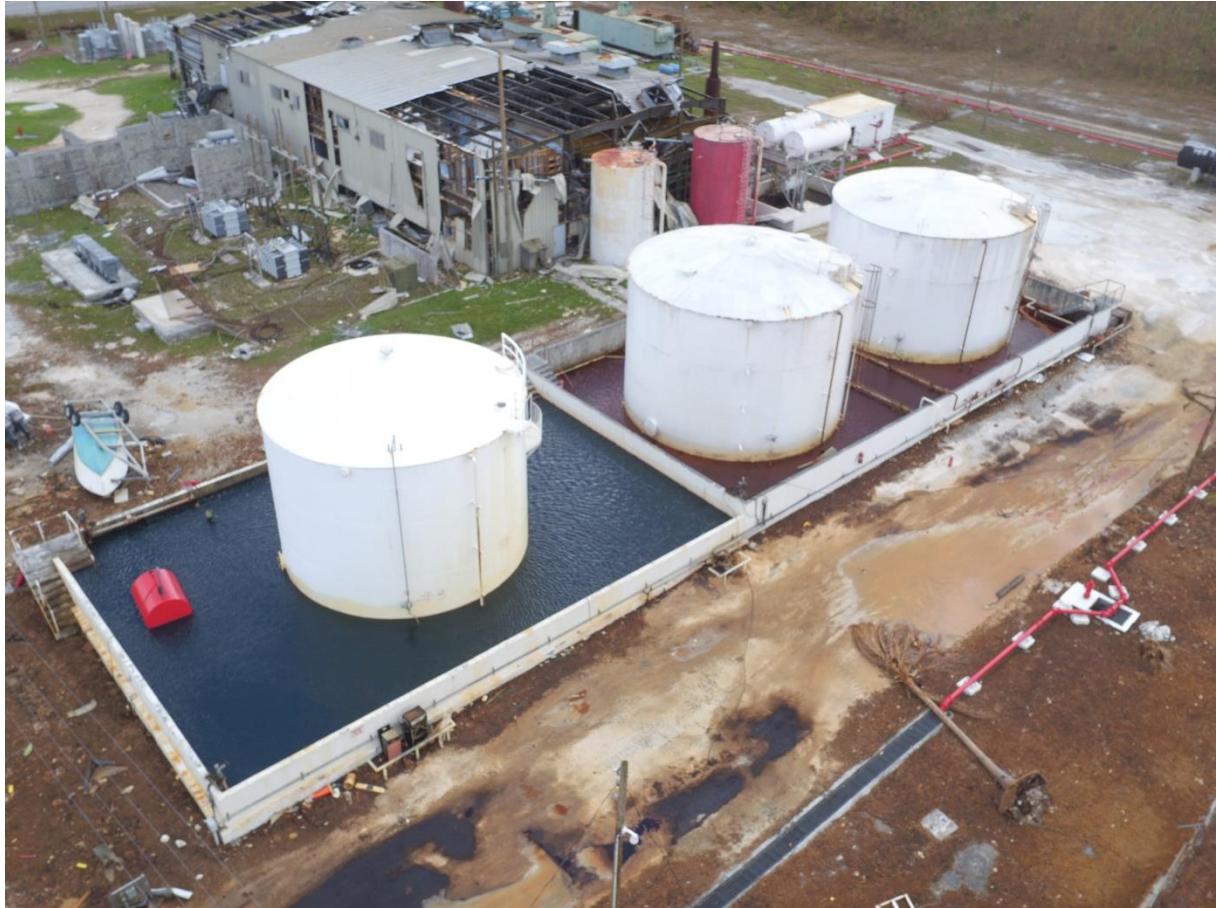
At the time of the site survey, on 13 September, a significant amount of fuel was found in the containment surrounding the tanks. This could have been caused either by continuous flow from the tank valves that may have been left open by fuel looters in the aftermath of the hurricane (when fuel was unavailable and a key priority) or by actual damage to the tanks/pipeline.

*Figure 3: drone view of BPL Marsh Harbour power sub-station, showing the three tanks, the amount of fuel in the containment and the wind spilled fuel leak (© UAS Dorian Relief)*

A small wind-blown diesel fuel leak occurred at the site. The fuel was spilled from the containment into the surrounding environment, within the plant's premises.

The operator informed that they did not have the capacity to intervene, since they had pumps but no storage capacity, nor immediate capabilities for full inspection of the status of the tanks. Support was identified in the Dutch Military Forces, which had hazmat qualified personnel and the necessary equipment for rapid intervention. Pumping operations started, with rotational shifts put in place by the Dutch troops to ensure 24-hour coverage for fastest execution of the task. Pending full verification of any damage to the tanks/pipeline, fuel sludge was pumped into one of the tanks found to be uncompromised as a temporary measure ahead of the tropical storm forecast.

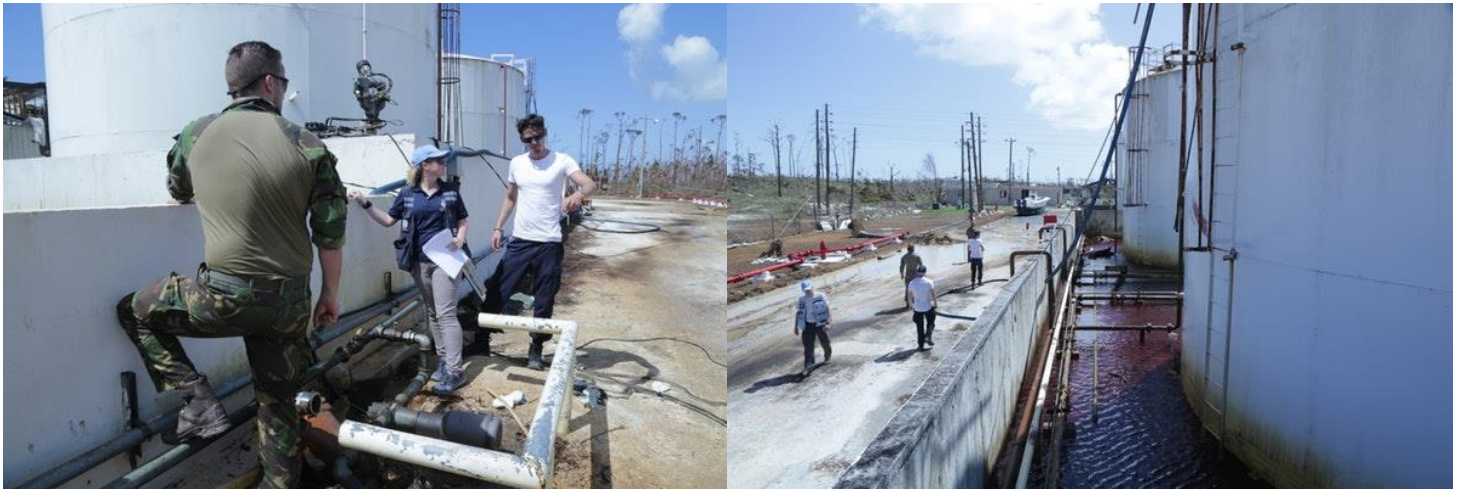
*Figures 4 (left) and 5 (right): Emergency pumping operations at Marsh Harbour power sub-station  
(©Christophe Illemassene, OCHA)*

The early identification of the issue; follow-up with the operator, the local NEMA representation, the Ministry of the Environment, the Royal Defence Force; and the rapid intervention with support from the Dutch Military Forces to inspect the site and pump the fuel out of the containment into a non-compromised tank, allowed for mitigation of risks and prevention of additional negative impacts.

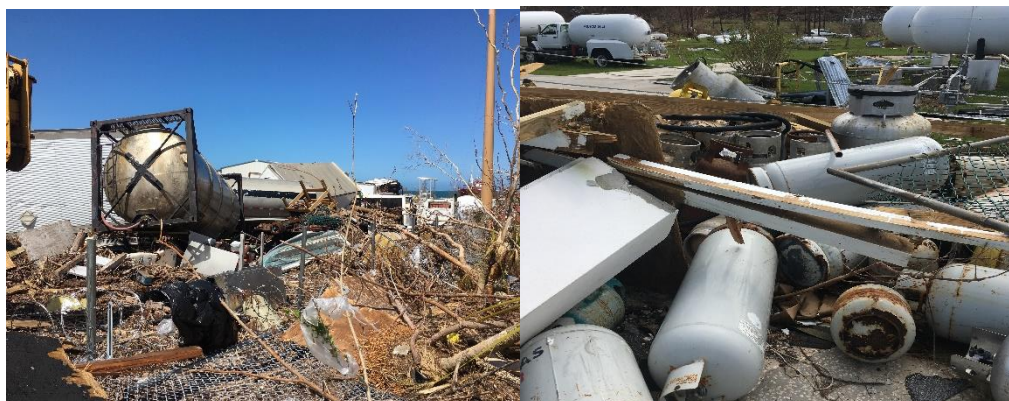
Several gas cylinders were blown away by the wind and spread across the site in unsafe conditions (Figure 7). Follow-up is required to restore safety at site.

*Figures 6 (left) and 7 (right): hurricane-impacted hazardous operation facilities in Abaco (Abaco Petroleum Company, left; Abaco Gas, right)*

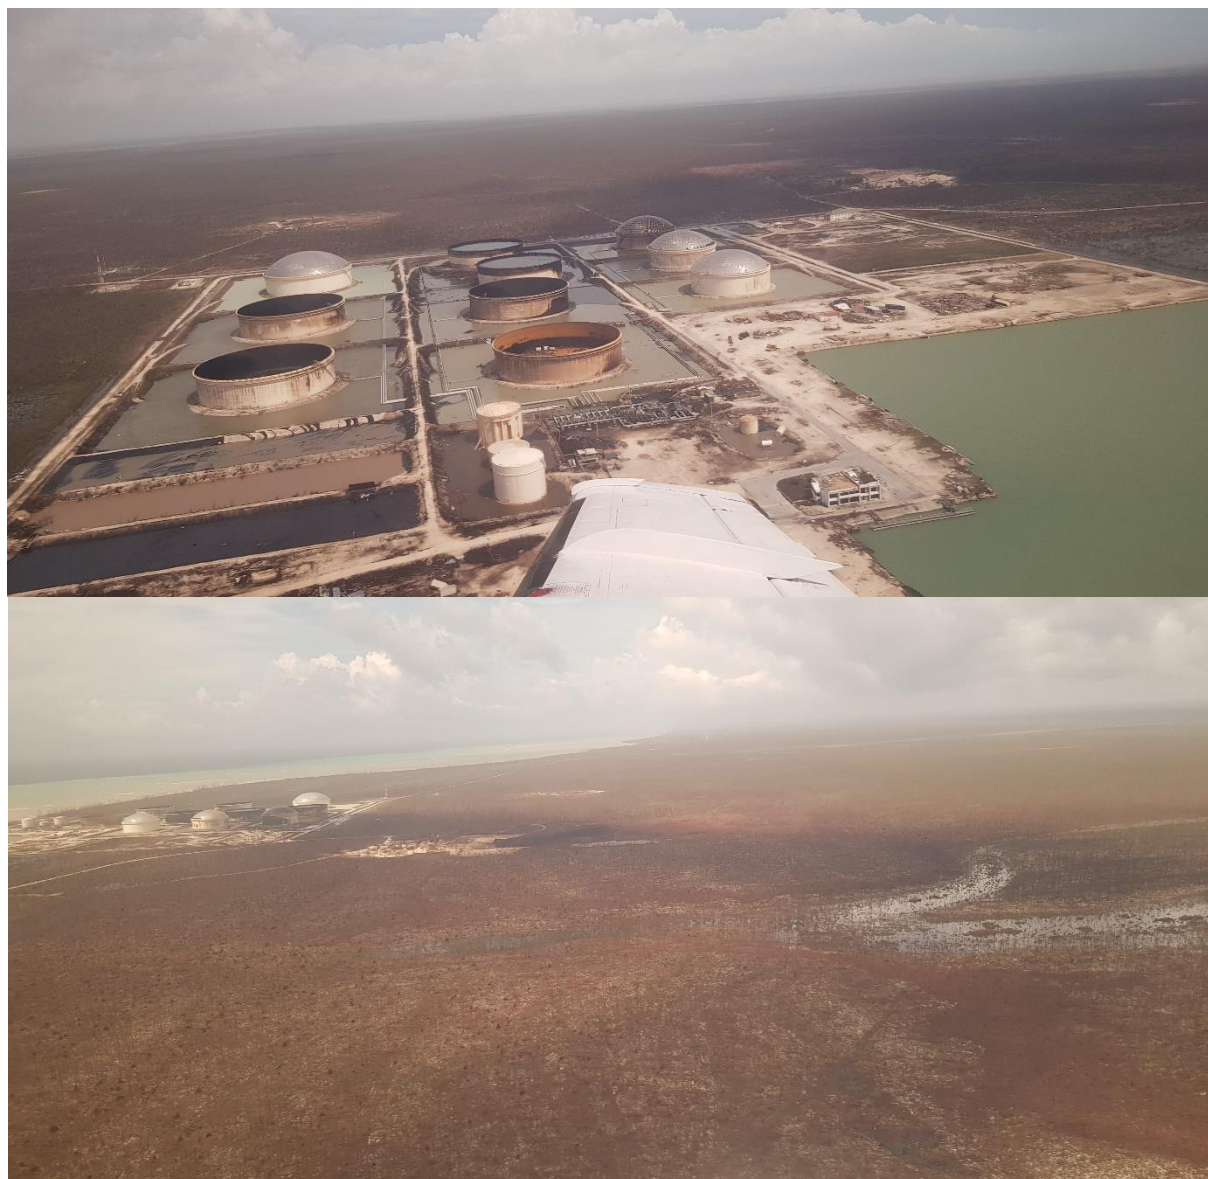
An inland spill of crude oil in the North-East direction was confirmed and noticeable from photo evidence made available by PAHO after an aerial assessment conducted on 4 September further to the all-clear (Figures 1 and 2).

*Figures 1 (above) and 2 (below): Inland spill of crude oil from Equinor oil storage facility as of 4 September 2019 (© PAHO)*

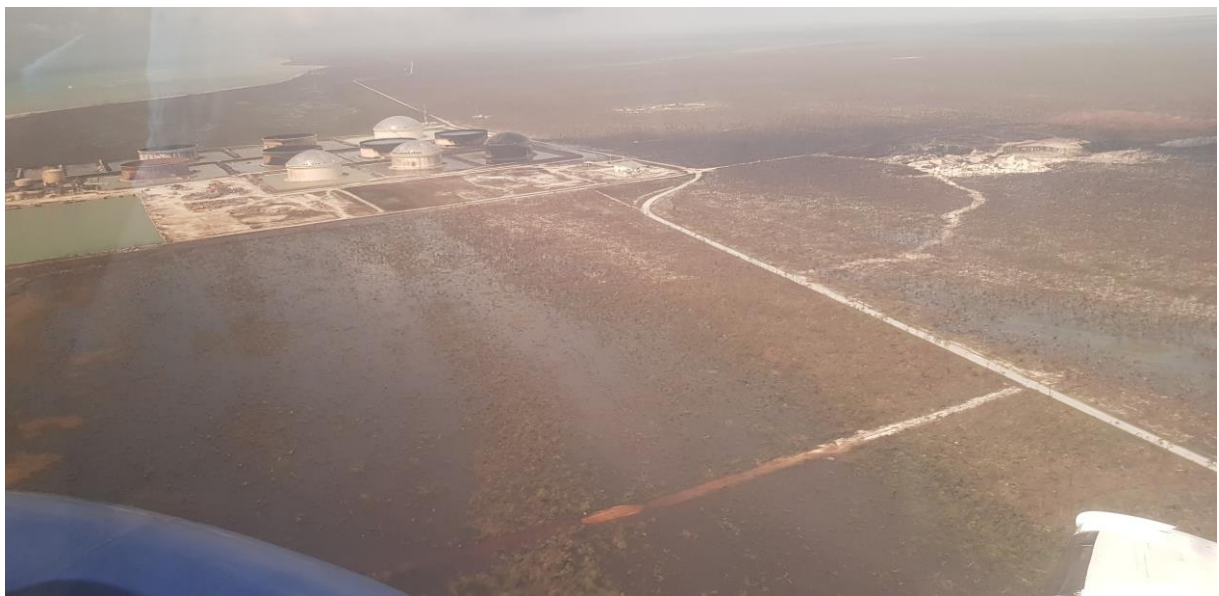
As a result, crude oil was wind-spilled from the two full tanks along the hurricane's northeast direction, impacting mainly inland areas, with a length of about 7 miles and an approximate width of 3 miles. Plumes of oil sprayed over the nearby vegetation were already visible from the first aerial assessments conducted on 4 September after the all-clear was issued. Photo evidence also shows that the East side of the plant experienced flooding (Figure 3). The flood trace was mapped by the European Commission's Copernicus Emergency Management Service based on an analysis of satellite images (Annex 5). The spill contaminated both the surface layer of soil (estimated at 5 cm) and vegetation in the area nearest to the plant, and vegetation only in the farthest areas (Figure 4).

*Figure 3: Aerial assessment of the facility, showing the plume of oil along the northeast direction as well as flooding on the East side of the plant (© PAHO)*

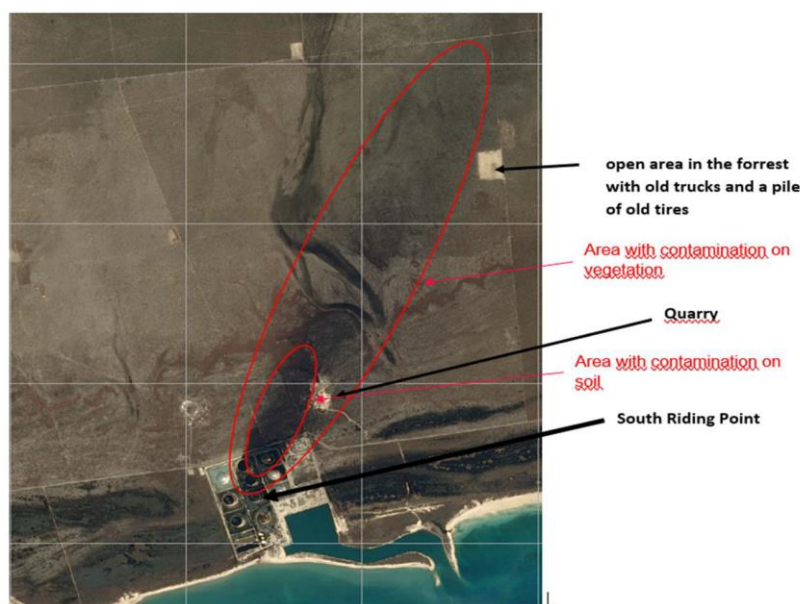
Figure 4: Extent of oil contamination inland (© Equinor)

The distinction between the impacted and non-impacted areas is very clear: a straight line could be drawn. This means that the blowing of the tank domes and consequent spilling of oil most likely occurred within a very short period of time (in the order of a few minutes), but with intense violence.

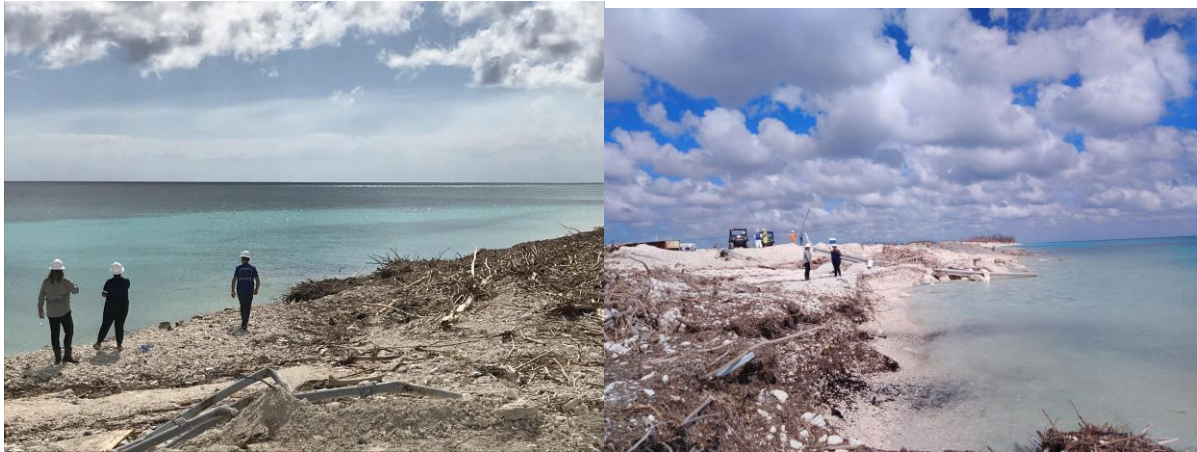
reveal the presence of crude oil along the coast and in the wetlands surrounding the facility (Figures 5, 6 and 7). Limited amounts of crude oil may, however, have reached the north coast of the island due to the runoff of oil caused by inland flooding.

*Figures 6 (left) and 7 (right): Site survey along the beach near the facility on 24 September, which showed no evidence of oil that could have been spilled at sea. Little droplets of oil were found on the beach due to the vortex created by the storm*

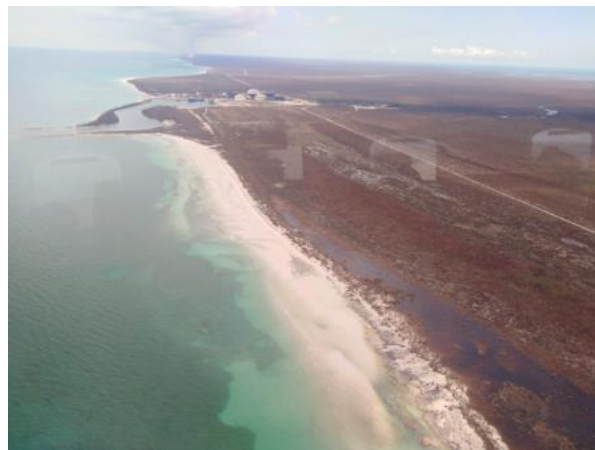
*Figure 8: Helicopter view of the shoreline to the East of the oil storage facility and of the surrounding wetlands that appeared free of crude oil*

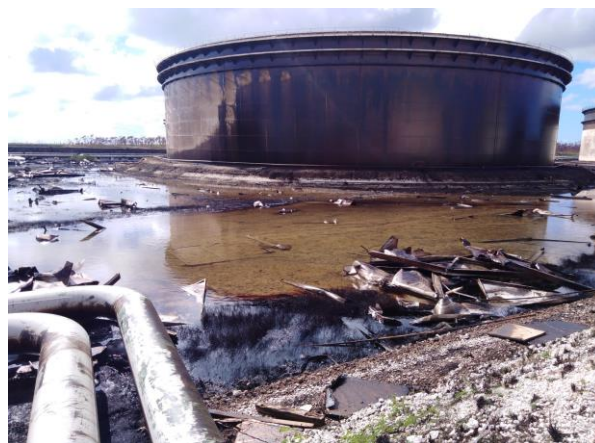
*Figure 9: The containment basin around the tanks forms a closed system without drainage of rain water. This is confirmed by the presence of water and crude oil inside the basin*

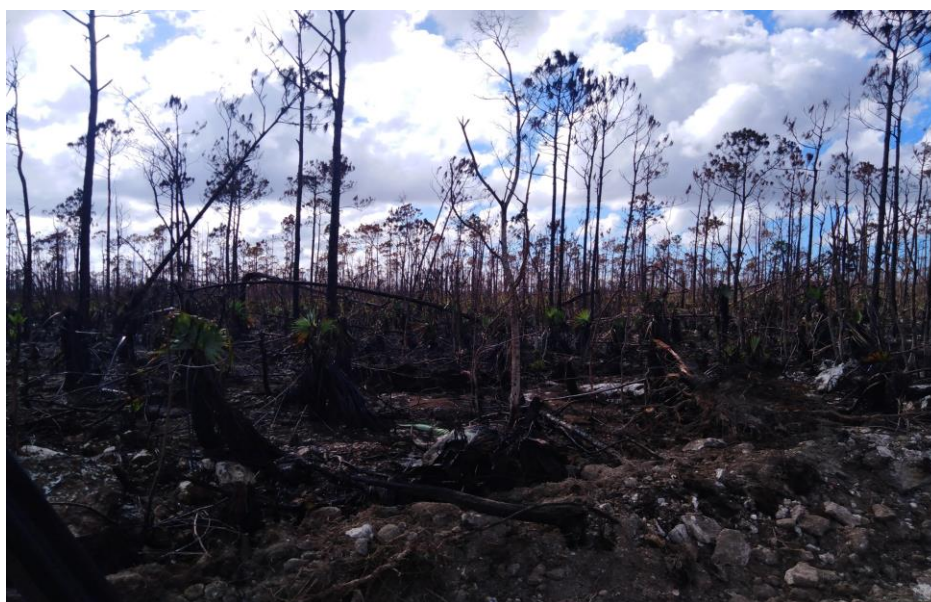
Figure 10: Pineland contaminated by crude oil

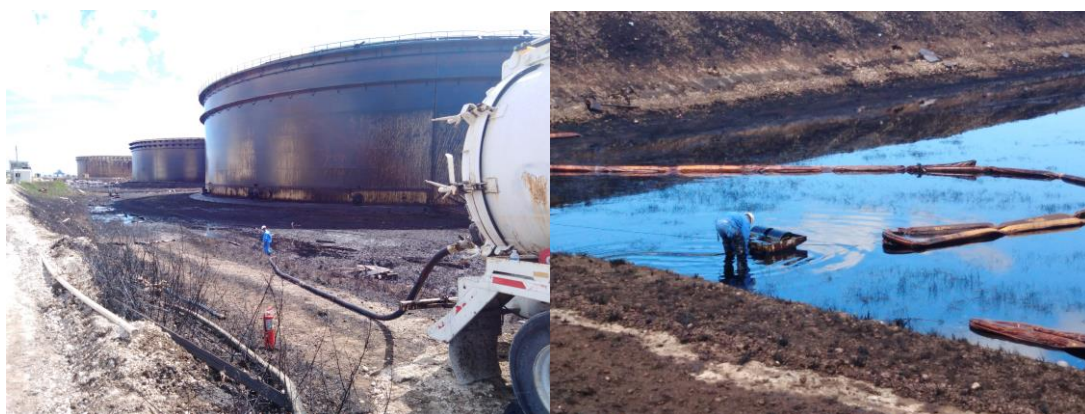
*Figure 10 (left) and 11 (right): Collection of crude oil is carried out using vacuum trucks (left) and oil skimmers (right)*

Equinor has been carrying out clean-up operations since 8 September. Free oil is collected using 13 vacuum trucks and oil skimmers (Figures 10 and 11). As of 24 September, 6000 barrels of oil had been recovered and stored in pond n. 3, which has a total capacity of 12,000 m<sup>3</sup>. The pond was reportedly less than 1/3 full at the time of the mission.

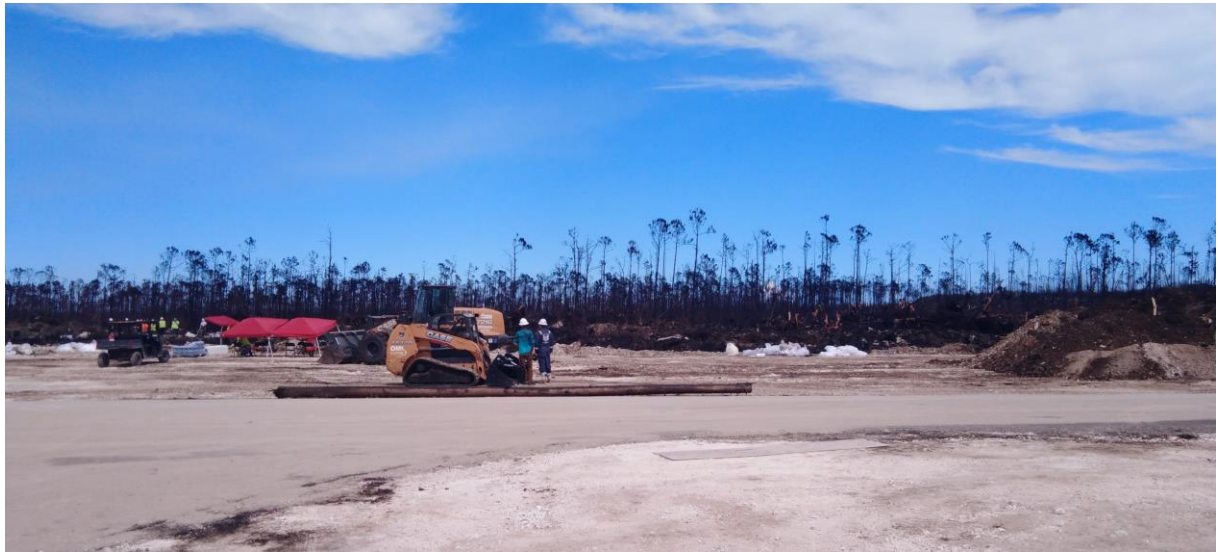
*Figure 12: Removal of contaminated soil with bulldozers*

Bahamas Hub, the other oil storage facility on Grand Bahama Island. The final destination of the oiled soil would be the landfill itself, to be used for the top cover. The staff at the landfill facility does not have any experience in reusing/recycling. At the time of the mission, the site manager was not able to provide information on the quantities that the landfill could receive and be capable of disposing, also due to the uncertainty over actual waste figures.

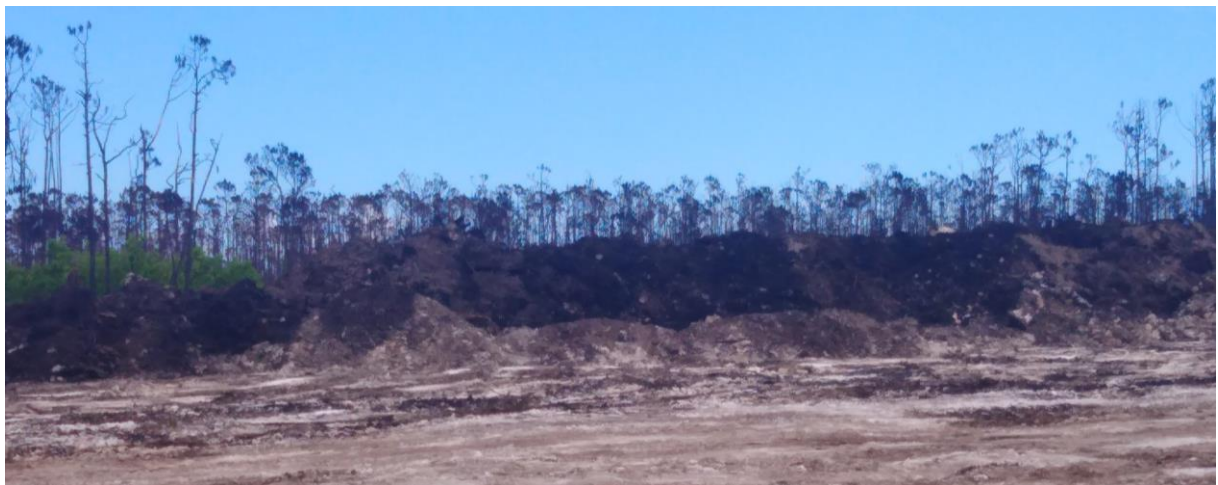
*Figure 13: Oiled soil accumulation, removed with bulldozers*
